Integration of Remote Sensing and GIS Techniques for Flood Monitoring and Damage Assessment: A Case Study of Naogaon District, Bangladesh

Abdullah-AI Faisal, Abdulla-AI Kafy* and Sumita Roy

Department of Urban and Regional Planning, Rajshahi University of Engineering and Technology (RUET), Rajshahi, Bangladesh

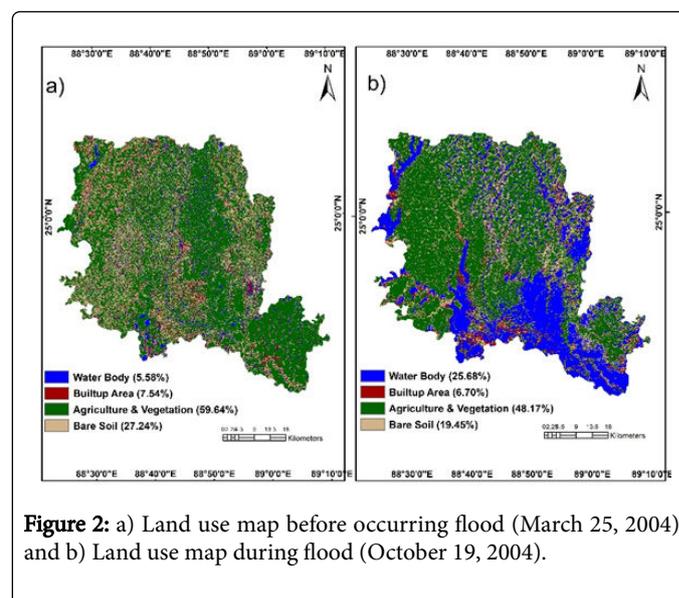
Figure 2: a) Land use map before occurring flood (March 25, 2004) and b) Land use map during flood (October 19, 2004).

The study area has experienced a huge amount of changes due to flood during the year between 2004-2017. For the year of 2004, two Landsat images are taken for analysis purpose. Figure 2 shows the land use changes for two months in year 2004. In the figure, the image of (a) March 25, 2004 which is taken for showing the land use conditions before occurring flood and the image of (b) October 19, 2004 is taken for showing the lands use conditions of during flood.

The interpretation of Landsat image (a) represents that the study area was 5.58% of the water body, 7.54% of the built-up area, 59.64% of agricultural and vegetation land and 27.24% bare soil of 3449.197 sq-km area. The data shows only 5.58% of water body existed before an overflow of water. But after increasing the overflow of water in the month of October 2004, the percentage of water body represents a massive change. The Figure 2b shows the massive changes of water body during the flood which affected all other land uses. The figure represents that the percentage of water body converted from 5.58% to 25.68% which impacts on all other land uses. Due to an increase of water body, the percentage of built-up area was also shifted from 7.54% to 6.70%. Similarly, increasing of water body also effects on agricultural and vegetation land and the percentage was shifted from 59.64% to 48.17% of 3449.197 sq-km lands. The percentage of bare soil also decreased from 27.24% to 19.45%. The results indicate that, due to the overflow of water most vegetation and agricultural land were flooded which washed out most of the agricultural crops and causes negative impacts on rural people as well as economy. In addition, 0.84% of the built-up area was also flooded because of occurring flood and people became homeless. The most underlying finding of the analysis of the flood of 2004 is, the flood covers most of the land about 692.3052 sq-km area of Naogaon District and washed out a huge amount of agricultural crops and built-up areas.

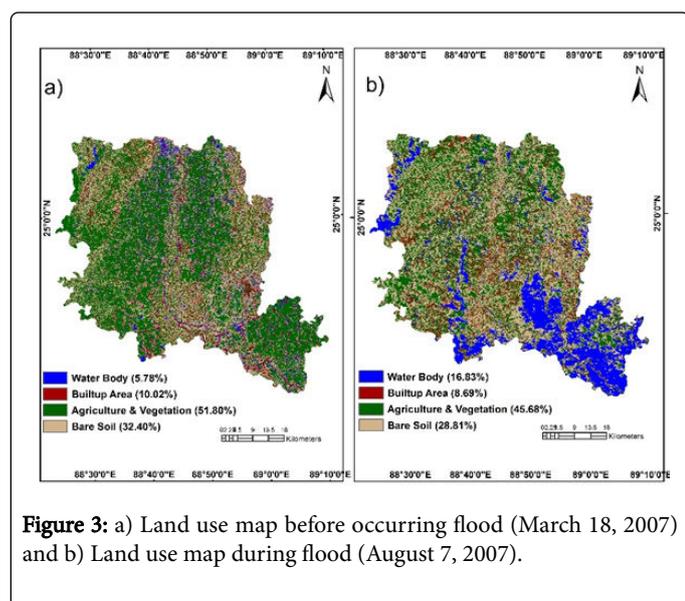
Figure 3: a) Land use map before occurring flood (March 18, 2007) and b) Land use map during flood (August 7, 2007).

Another analysis is taken place of the year of 2007 in Naogaon District. Figure 3 represents the land use changes where the image of (a) March 18, 2007 which is taken for showing the land use conditions before occurring flood and the image of (b) August 7, 2007 is taken for showing the lands use conditions during flood. The comparison of the two images gives the information about the land use changes and by why the changes occurred. If anyone concentrates the water body changes of the year of different months, then the percentage of flood damage will be clarified. The Figure 3b shows the conditions during the flood where the percentage of water body was 16.83% which was converted from 5.78%. The amount of and flooded was 380.8071 sq-km of 3449.197 sq-km. Due to an increase of water body, the percentage of built-up area was also shifted from 10.2% to 8.69%. Similarly, increasing of water body also effects on agricultural and vegetation land and the percentage was shifted from 51.80% to 45.68% of 3449.197 sq-km lands and bare soil land was shifted from 32% to 28.81% due to flood. The result indicates that, due to the overflow of water most vegetation and agricultural land were flooded which washed out most of the agricultural crops and causes negative impacts on rural people as well as economy. In addition, 1.33% of the built-up area was also flooded because of occurring flood and people became homeless.

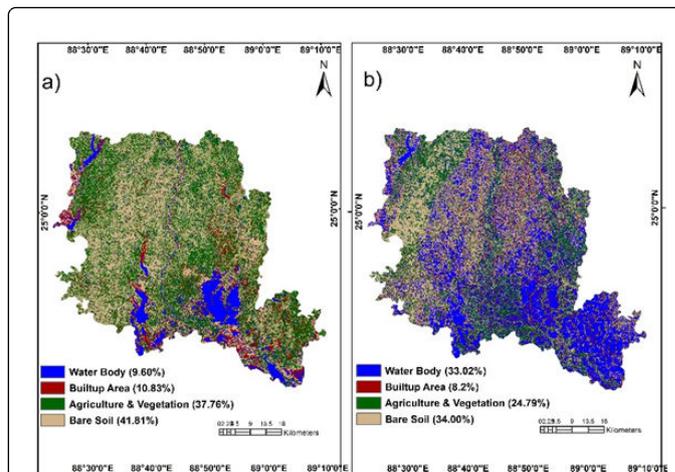
Figure 4: a) Land use map before occurring flood (March 18, 2012) and b) Land use map during flood (June 30, 2012).

Figure 4 shows the land use changes where the image of March 18, 2012 (a) which is taken for showing the land use conditions before occurring flood and the image of June 30, 2012 (b) is taken for showing the lands use conditions of during flood.

The interpretation of both images represents the geographic descriptions of the flood. In April there was only 9.60% of water body but after occurring flood, it raised to 33.02%. The percentage shows the deadliest effects of the flood that not only affected by water body but also affected all other land uses. The flood washed away 2.63% of the built-up area which caused a huge amount of economic losses as well as made the victims homeless. It also washed away the extensive amount of agricultural and vegetation lands where percentage fall down from 41.81% to 34.00%.

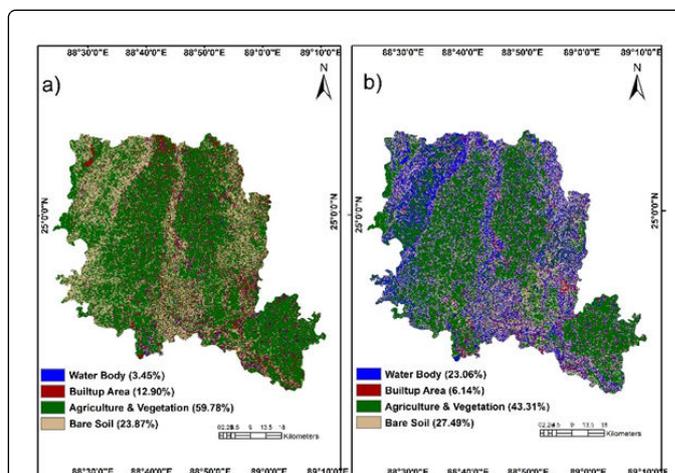
Figure 5: a) Land use map before occurring flood (April, 2017) and b) Land use map during flood (August, 2017).

Recently the deadliest flood occurred recently all over Bangladesh especially in the northern portion of the country. As Naogaon is situated in the northern portion of Bangladesh, that's why the district was a direct victim of the action of the flood. For analysis purpose two Landsat images are taken which is shown in Figure 5. In the figure, represents the land use changes during the year of 2017. In the figure, the image of April 14, 2017 (a) which is taken for showing the land use conditions before occurring flood and the image of August 5, 2017 (b) is taken for showing the lands use conditions of during flood.

The result shows that, the percentage of water body increased because of the overflow of water from 3.45% to 23.06% of 3449.197 sq-km. It indicates that the increasing water affected all other land uses mostly in agricultural and vegetation lands. The land uses such as built-up area was shifted from 12.90% to 6.14%, agriculture and vegetation lands were shifted from 59.78% to 43.31%.

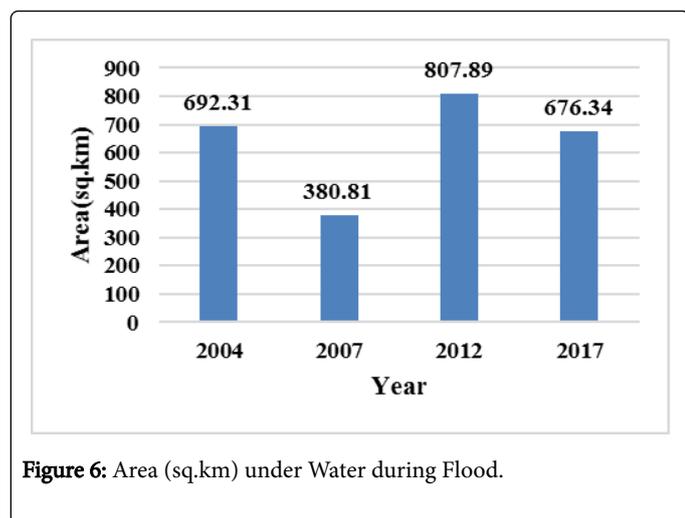
Figure 6: Area (sq.km) under Water during Flood.

Figure 6 represents the flooded area with respect to their corresponding year. In 2004 693.31 sq-km land was flooded and in 2007 the total under water land area was decreased to 380.81 sq-km. But in 2012, another flood acted in Naogaon District and the total flooded area was increased to 807.89 sq-km and recently in 2007 the total flooded area was 676.34 sq-km.

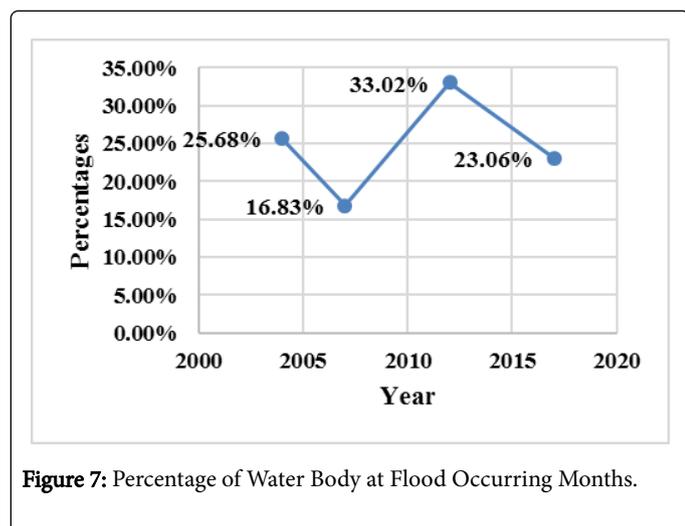
Figure 7: Percentage of Water Body at Flood Occurring Months.

Figure 7 shows the percentages of the water body at flood occurring months. The line shows that, in 2004 the percentage of water body increased to 25.68% due to flood. Similarly, due to flood, the percentage of water body increased in 2007, 2012 and 2017 to 16.83%, 33.02% and 23.06%. The key finding of the analysis is, the percentage of a water body can be increased more than 30% and if it will, then the extensive area of valuable land would go under water and would create a physical and economic loss of Naogaon District.

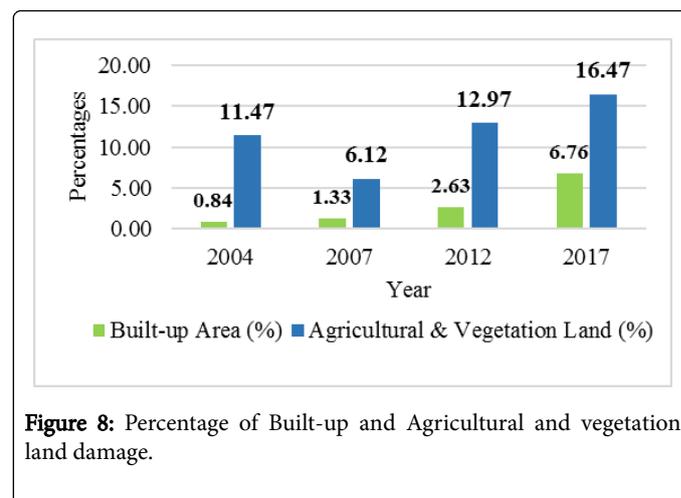
Figure 8: Percentage of Built-up and Agricultural and vegetation land damage.

Figures 8 and 9 shows the total percentage of loss during flood with their corresponding year. The figure represents that percentage of damage to built-up area was increasing year after year, that means due to increasing of urbanization, built-up area damages was increasing

from 0.84% to 6.76%. In the year 2017, people of Naogaon District suffered most because of losing their household due to food.

In addition, the figure also represents the total percentage of agricultural and vegetable damaged land with its corresponding year. The percentage fluctuated in a different year. In 2004, the percentage was 11.47% but in 2007 the percentage decreased to 6.12%. After 2007, the damage of agricultural and vegetation land was increased and turned to 16.47% in 2017. The most underlying key point is that, day-by-day due to flood, property as well as agricultural and vegetation lands are destroyed most and therefore the economic loss is increasing constantly which adversely affect the country's economic condition.

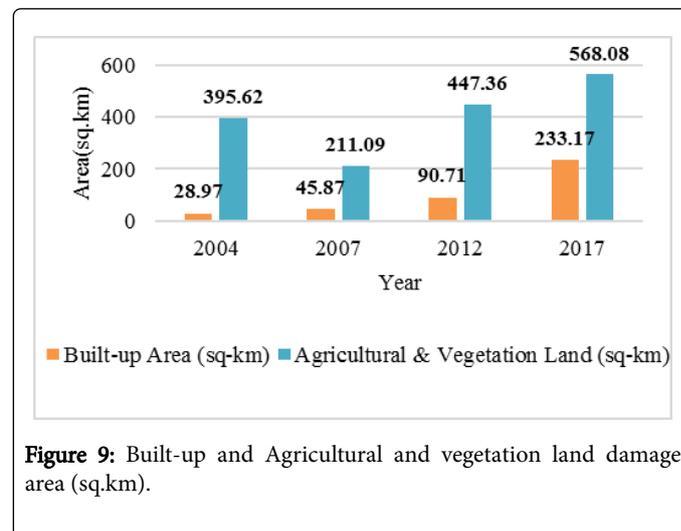
Figure 9: Built-up and Agricultural and vegetation land damage area (sq.km).
