Multifunctional floodplain management and biodiversity effects: a knowledge synthesis for six European countries

ONLINE RESSOURCE 1

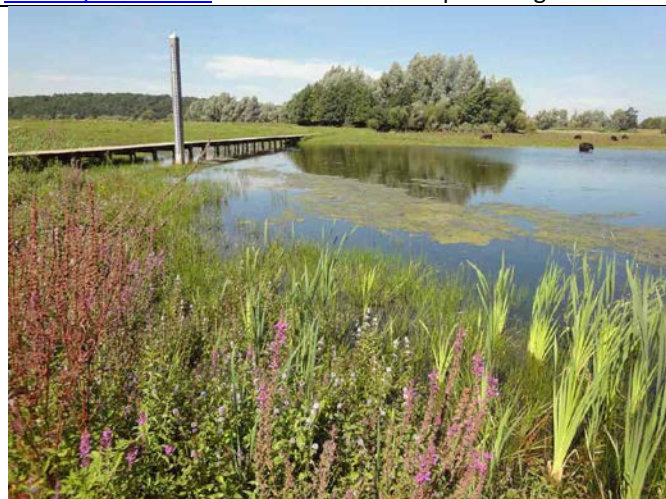
De Blauwe Kamer

depoldering

River branch	Neder-Rijn (Lower Rhine)
Province	Utrecht / Gelderland
Community	Rhenen
Start nature development	1984 procurement, 1992 design
Owner / manager	UtrechtsLandschap
Area	120 ha
Accessibility	partially accessible on the paths, partially closed
Measures	<ul style="list-style-type: none"> • lowering the embankment in two places, • construction of a side channel, • heightening the ground level of the meadow, • construction of an isolated shallow swamp, • construction of an inland drainage system

Species group	Before nature restoration		After nature restoration		Evaluation development
	Number of (rare) species	Number of Red List species	Number of (rare) species	Number of Red List species	
Flora*	48-54	22-23	50-66	23-25	
Breeding birds*	36	?	max 75	max 20	
Dragonflies*	17-20	1	35	4	
Butterflies*	24	3	24-27	2-3	
Grasshoppers*	12	1	14	1	
Other species	Beaver, grass snake, Natterjack toad (<i>Epidaleacalamita</i>)				
* = all species

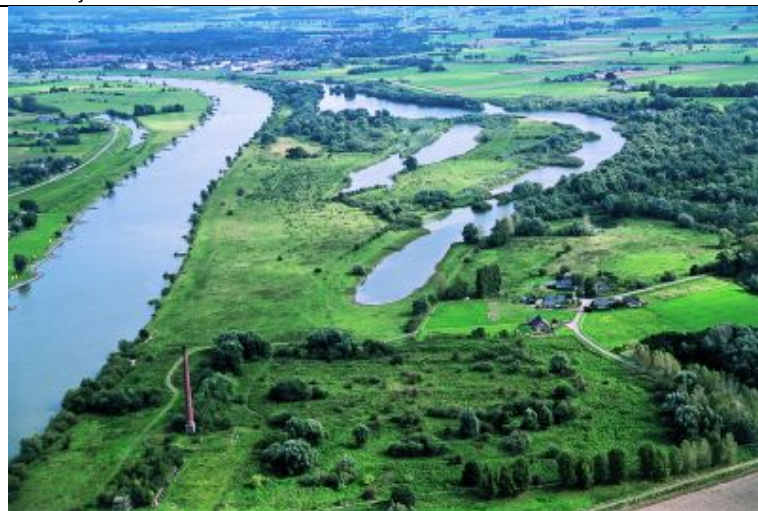
River branch	IJssel
Province	Overijssel
Community:	Olst-Wijhe
Start nature restoration	1987 floodplain meadow (grazed), 1989 design
Owner / manager	Staatsbosbeheer
Area:	150 ha (70 ha grazed)
Accessibility	partially accessible
Measures	<ul style="list-style-type: none"> • The construction of a downstream connected channel in 1989; • Part of the sand lake is filled in, part of a floodplain meadow was raised; • Construction of an observation hut from the dyke on the northern side of the ditches (1989); and of an observation tower at the brick factory; • The extension of the ditches in 2006 on the south-west side of the territory (third lob); • The construction of a natural border on the north side of the territory in 2005, by removing the hard riverbank substrate and part of the top layer, a sandy border remains, groynes stayed and there is a construction to restrict access by boats.

Results	Before nature restoration		After nature restoration		Evaluation development
Species group	Number of (rare) species	Number of Red List species	Number of (rare) species	Number of Red List species	
Flora*	12-14	7	29	11	
Breeding birds*	31	12	+/-35	11	
Dragonflies*	?	?	27-29	5	
Butterflies*	19	0	29	4	
Grasshoppers*	12	1	13	1	
Fish*	?	?	20	4	
Amphibians*	6	2	4	0

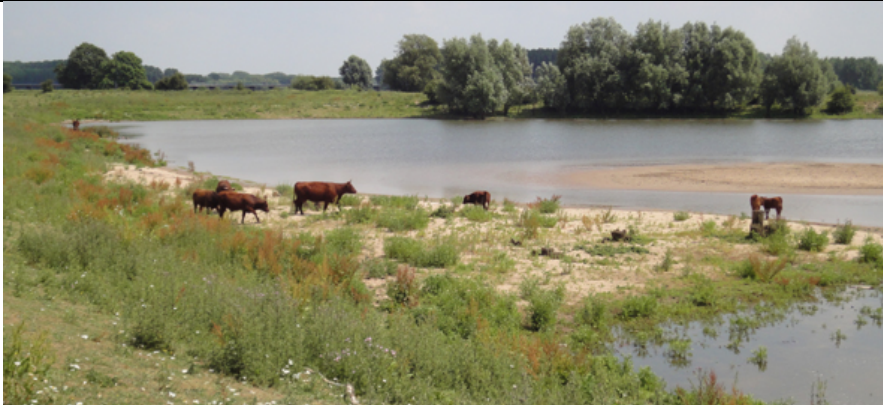
Leeuwsche Waard www.rijnbeeld.nl		excavation of the floodplain topsoil

River branch		Waal	
		Province		Gelderland	
		Community:		Druten	
		Start nature development		1994	
		Owner / manager		Dekker van de Kamp	
		Area:		About 115 ha (sand lake included)	
		Accessibility		partially free accessible (western part), the eastern part is closed	
		Measures		<ul style="list-style-type: none"> • End of 2003: first phase filling up the Kaliwaal; • 2003: north eastern side a temporary quay is constructed; • 2003: Lowering a large part of the space between the shore and the summer dyke; • 2008: Realisation of a large oxbow around the Kaliwaal; • 2008: Elongating the quay along the south side of the Kaliwaal to the Leeuwsche Waard; • 2008: Construction of a new quay on the dyke side of the oxbow 	
Picture of the Leeuwsche Waard (www.rijnbeeld.nl)					
Species group	Before nature restoration		After nature restoration		Evaluation development

Number of (rare) species	Number of Red List species	Number of (rare) species	Number of Red List species	
Flora*	18	5	32-41	10	
Breeding birds*					
Dragon flies*	18	0	18	2	
Butterflies*			17	1	
Grasshoppers*	7	0	10-11	1	
Other species

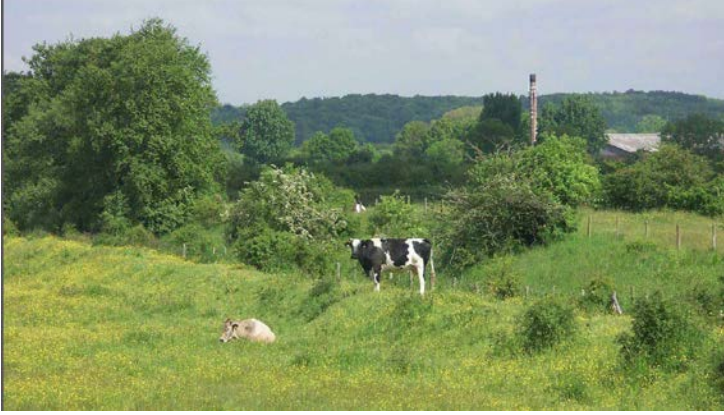
<p>Oeffeltermeent (http://maasinbeeld.nl/2/?cat=36)</p> <p>Excavation of the floodplain top soil</p>

<p>Relocation of the dyke</p>

<table><tr><td>River branch</td><td>Meuse</td></tr><tr><td>Measures</td><td> <ul style="list-style-type: none"> • Construction of a summer dyke, to avoid flooding of rare and valuable floodplain meadows (early 80s) • Excavation of livestock ponds as part of nature restoration (early 90s); • Removal top soil to restore ruderal conditions in part of the area (1991); • Reconstruction and strengthening of river dyke. </td></tr></table>

Species group	Before nature restoration		After nature restoration		Evaluation development
	Number of (rare) species	Number of Red List species	Number of (rare) species	Number of Red List species	
Flora*	41	26	36	20	
Breeding birds	22	12	22	9	
Dragonflies*	?	?	15	2	
Butterflies*	?	?	23	2	
Grasshoppers*	?	?	8	0	
Fish					
Herpetofauna		0	6	2

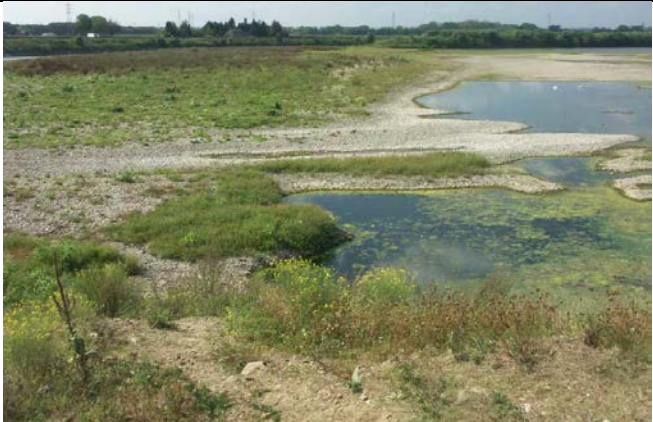
Pilot project Meers http://www.maasinbeeld.nl/publicaties/ProefprojectMeers.pdf (Peters et al. 2007)

River branch	Meuse	
	Province	Limburg	
	Community:	Stein	
	Start nature restoration	1998	
	Owner / manager	Natuurmonumenten (NGO), mineral extraction company	
	Area:	53 ha (grazed)	
	Accessibility	accessible	
	Measures	<ul style="list-style-type: none"> • Widening riverbed over 200m, lowering river bank • (Partly) Filling in deep gravel pit (lake) • Landscaping of the gravel pits • Establishment recreation facilities • Establishing one grazed management unit • Construction shallow gravel channel along river

Species group	Before nature restoration		After nature restoration		Evaluation development
	Number of (rare) species	Number of Red List species	Number of (rare) species	Number of Red List species	
Flora*	28	12	57	30	
Breeding birds	13-15	8-11	13-17	8-10	
Dragonflies*	?*	0	22*	2	
Butterflies*	10*	1	15*	3	
Bats*	?	?	3*	3	
Other species					Beaver, Blue-winged grasshopper
Fish					Many important rheophile fish species returned
